Weybridge fire incident report

NHS Property Services Report into the Fire at the Weybridge Community Hospital

**Weybridge Community Hospital
Church Street
Weybridge
KT13 8DY**

Date of this Document: **Version 3.1 – 14th May 2018.**

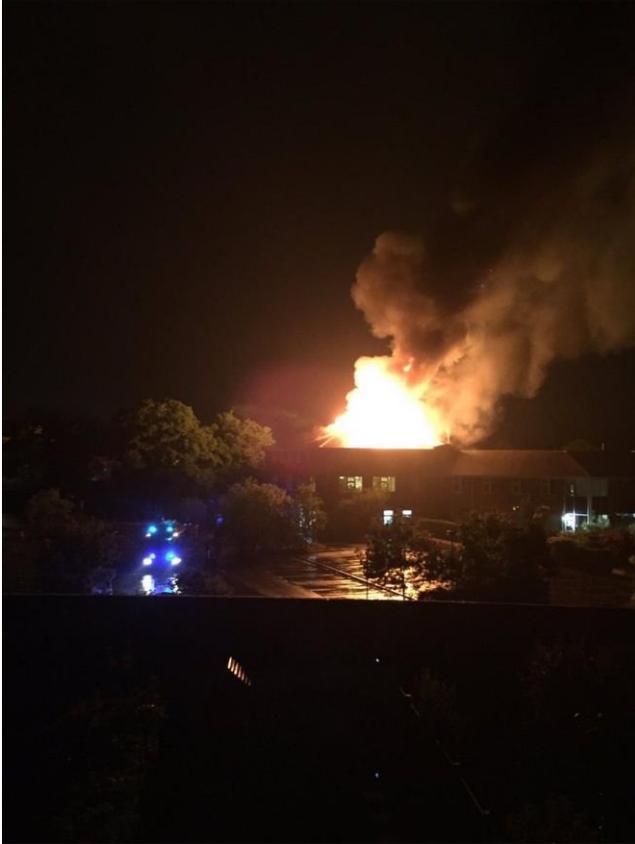
Photograph A1. Showing roof above main entrance on fire

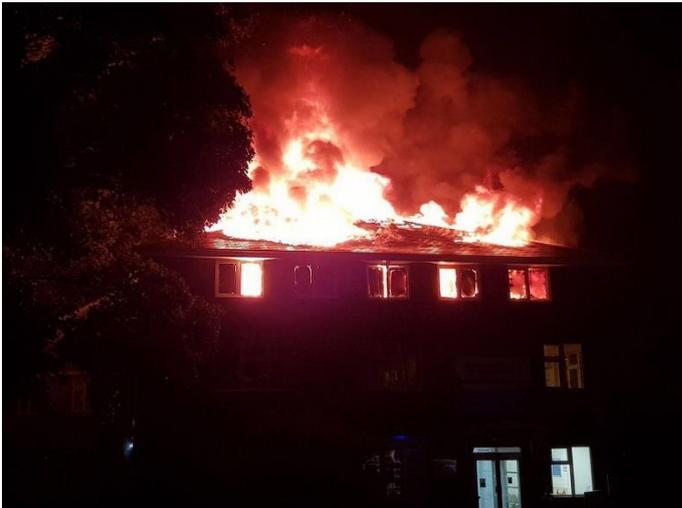
Photograph A2. Showing extent of fire in main entrance of building
